# ***Electric Energy T&D*** **MAGAZINE**

2016 Storm Restoration and Vegetation Management Supplement

# How Laser Technology Simplifies Vegetation Management and Protects the Grid

# Keeping Animals Out, Keeping the Lights On

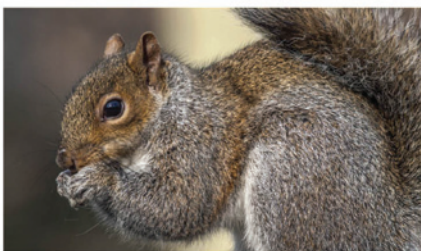
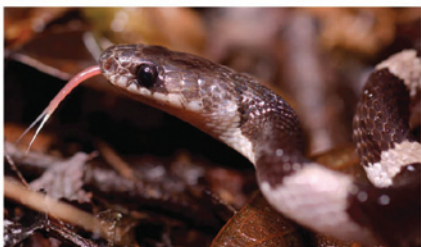
Animals causing outages

In St. Augustine, Florida, a power outage caused by a squirrel damaging key components at a utility station led to a sewage backup, ultimately resulting in 60,000 gallons of untreated sewage flowing into the San Sebastian River.

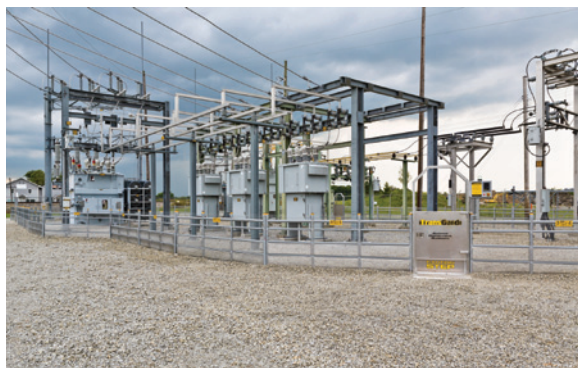
Complete installation: patented, modular design delivers mild electric shock preventing climbing animals from entering the facility

The fence was designed exclusively for substations: it's modular, durable, and installs in half a day without any interruption to power. To date, the company has installed fencing at more than 2,500 North American substations – substations operated by dozens of major utilities, electric cooperatives, municipalities and other power suppliers.

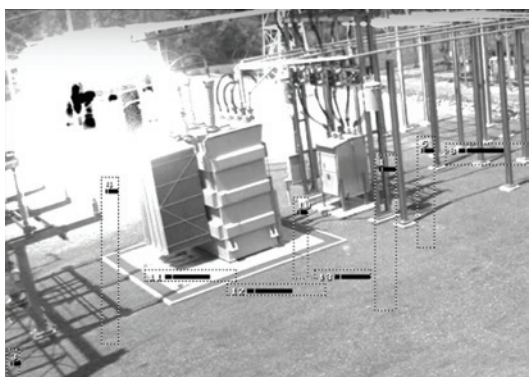
Substation explosion caused by a snake
